How safe are the safety mechanisms? Incident Reporting

Abstract

Critical incident reporting is an integral component of teaching in anesthesia practice. We hereby report a case of intraoperative hypoxia; where after excluding all conventional measures, it was realized that it was the malfunction of safety mechanisms, an extremely unexpected cause for intraoperative desaturation. Timely diagnosis and prompt action reverted the crisis situation.

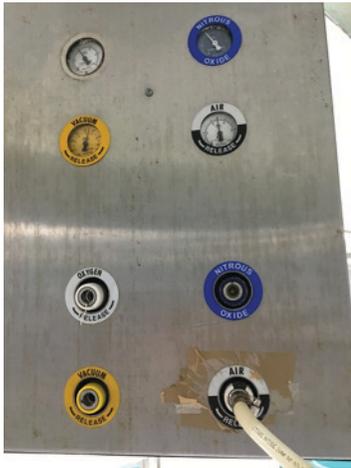
After all conventional measures, as a last resort, the senior anesthesiologist checked the pipeline connections and found the oxygen pipeline connected to air! (Fig. 1).

Figure 1: Oxygen pipeline connected to air accidentally; leading to the mishap!

We checked the connections again and to our surprise, the oxygen pipeline could be easily fitted to air that leads to delivery of hypoxic mixture to the patient. The DISS was dysfunctional. Timely diagnosis of the least expected cause and prompt action reverted the condition, which could have been detrimental otherwise.

Corrective measures were taken immediately, and the saturation improved to 99–100%.

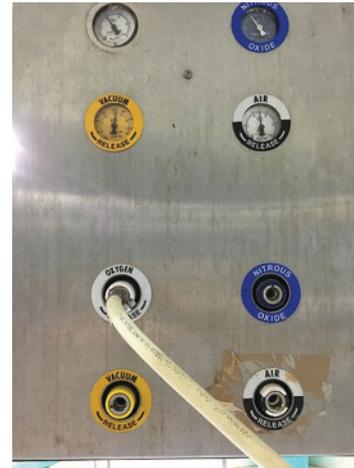
Figure 2: DISS and correct approximation of oxygen pipeline to its port on pendant.

DISS was developed to provide non-interchangeable connections for medical gas pipelines (Fig. 2). DISS connector consists of body, nipple, and nut combination. There are 2 concentric and specific bores in body and nipple. Small bore mates with a small shoulder and large with a large shoulder.^[2]

The apparatus can be connected or disconnected by a single action without the use of tools or undue force. Two diameters on each part vary in opposite directions.
